# Can GPS Be Used for Location Based Services at Schiphol Airport, the Netherlands?

Dennis Odijk and Frank Kleijer, *Delft University of Technology, The Netherlands*

**Abstract**—Schiphol Airport in the Netherlands is one of the main airports of Europe. To improve the airport's procedures reliable and accurate positioning information is required. This paper investigates whether GPS (or in general) GNSS can provide such positioning information. Schiphol Airport is a challenging environment for satellite-based positioning, because the area is densely built, and GNSS signals should be received inside the buildings as well, enabling indoor Location Based Services. Several experiments using a low-cost receiver have been carried out to investigate the performance of GPS. Outdoors near the piers the position availability is very good: even at locations under passing the piers sufficient satellites are tracked to compute positions. Indoors the availability of GPS really depends on the characteristics of the building. Multipath errors can degrade the position accuracy significantly. The main conclusion reads that due to a lack of availability indoors, Location Based Services at Schiphol A

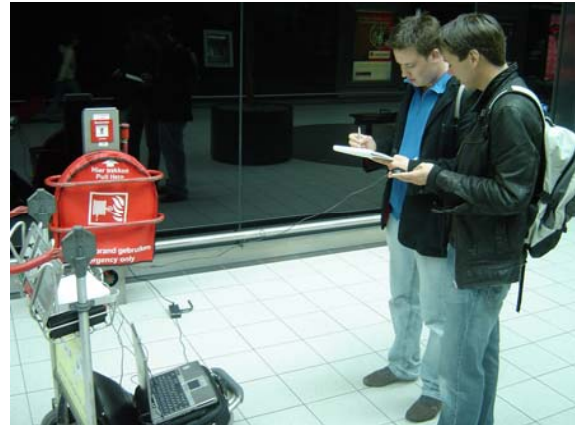
Fig. 2. Luggage trolley with u-blox receiver connected to a laptop, while the external (patch) antenna is held in hand.

For the indoor experiments the u-blox receiver kit was connected to a laptop (to store the NMEA messages) and carried on a luggage trolley. This trolley was pushed forward

with more or less constant walking speed, while an external (patch) antenna was held in hand, see Fig. 2. All measurements were collected with a frequency of 1 Hz on 9 May 2007, in the following areas of Schiphol Center (see Fig. 1):

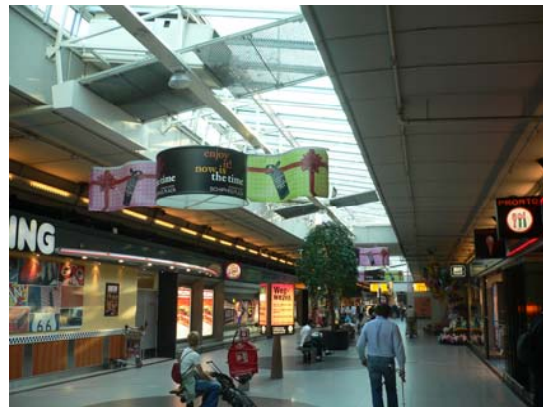
Fig. 5. Shopping corridor in Schiphol Plaza having windows in the roof.

The first experiment (from 12:27–12:48 UTC) started near the main entrance of Schiphol Plaza, outside at street level. The first three minutes the trolley was not moved in order to collect some static measurements. During this period the carrier-to-noise ratios of the signals tracked were up to 50 dBHz (see Fig. 4), and these are typical values for outdoor measurements with (more or less) direct lines-of-sight. Next, the trolley was moved forward on the street (see the green curve in Fig. 3). Along its way it under passed several obstacles: a large pedestrian bridge and a viaduct. During these passes however the number of satellites never dropped to zero; still about 7-8 satellites were used to compute positions. However, some deviation with respect to the followed path can be seen in Fig. 3, which might be due to multipath errors. At 12:33 UTC the trolley went inside a shopping corridor in the Plaza building (see Fig. 3) and immediately after entering only signals of at most 15-20 dBHz could be tracked. Due to this weak signal tracking unfortunately for some time intervals after 12.33 UTC no positions could be output by the receiver. After 12:35 UTC, still inside the shopping corridor, the tracked signals became stronger, which is due to the presence of windows in the roof from this point onwards (see Fig. 5). As a consequence of

GPS signals penetrating through these windows, positions could be fixed all the time (see Fig. 4), up to a point, at almost the end of the corridor. At this point no windows were present (from about 12.38 UTC), and positioning became problematic.

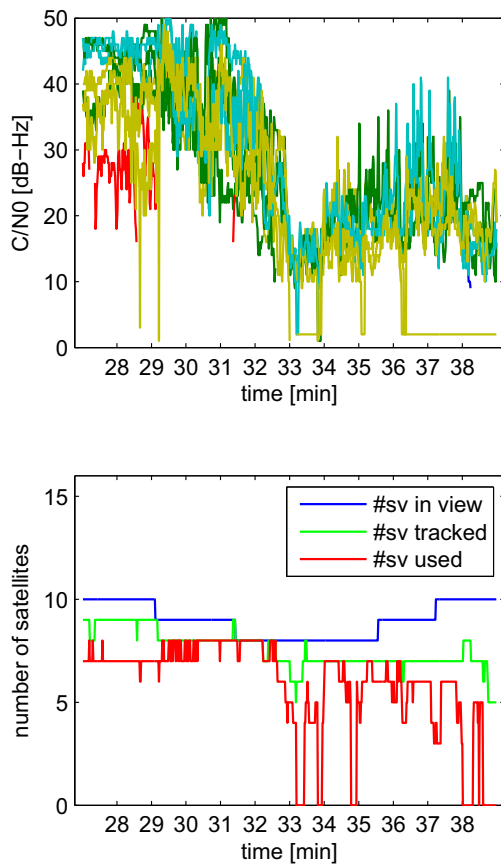
Fig. 4. Carrier-to-noise ratio  $C/N_0$  (top) and number of satellites (bottom) as function of time for experiment at Schiphol Plaza. The number of satellites ‘in view’ is the theoretical number of satellites (based on almanac data) the receiver can ‘see’, while the number of satellites ‘tracked’ is actually received. The number of satellites ‘used’ is the number that is used for the position computation.

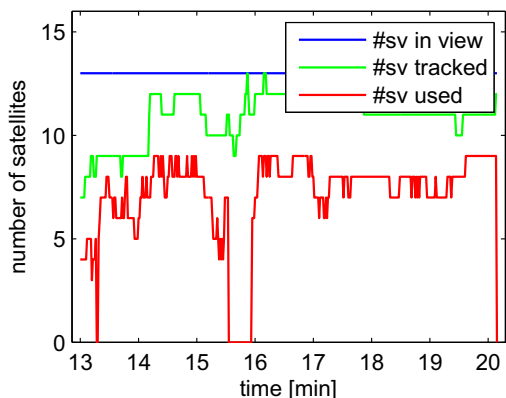
Fig. 7. Carrier-to-noise ratio  $C/N_0$  (top) and number of satellites (bottom) as function of time for D-pier experiment.

Fig. 6 shows the GPS position fixes during this experiment, while Fig. 7 depicts the carrier-to-noise ratios of the signals tracked and the number of satellites as function of time. It can be seen that the signals are relatively weak, having carrier-to-noise ratios lower than 30 dBHz all the time. For some time the receiver is not able to output position fixes; this can be seen in Fig. 6 close where the pier ‘splits’ into a northern and southern wing. For this period without positions the receiver still tracks sufficient satellites (see Fig. 7), however, the receiver does not decide to compute any positions. In Fig. 6 one can recognize a reasonably tall building above the location where the pier splits into two parts, which is most

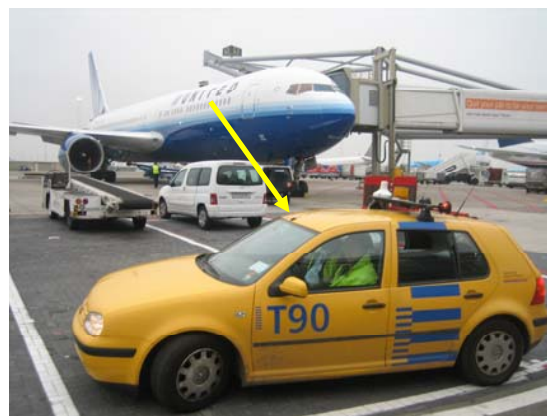
Fig. 8. Car used in Schiphol HSGPS outdoor test. The u-blox patch antenna is fixed to the roof of the car (see arrow).

Outdoors, the external patch antenna of the u-blox receiver was fixed to the roof of a car (see Fig. 8) and connected to a laptop inside the car. The car drove along the ring-road at the airport, which goes around Schiphol's terminal building and all piers (see Fig. 1). At several places this road underpasses the building and piers, making it a challenging environment to test the impact of these urban 'obstructions' to the performance of GPS. The test was carried out on 26 October 2007 from 9.47-10.05 UTC with a measurement frequency of 4 Hz.

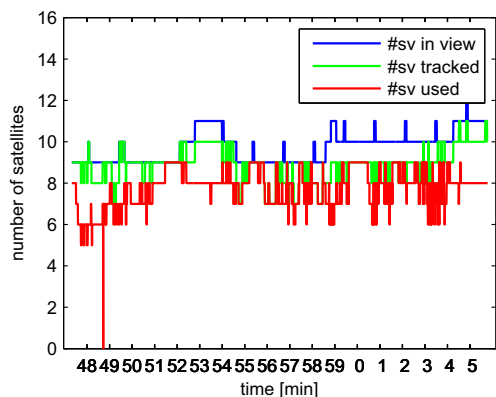
Fig. 10. Number of satellites as function of time for the ring-road experiment.

during this experiment: for only one epoch the signals were lost and no position be fixed by the receiver. For all other epochs at least 5 satellites could be used for the positioning computation (see Fig. 10). When looking at Fig. 9 one may see that the series of position fixes reasonably well resembles the ring-road trajectory, except for the area around the D-pier, where deviations are visible. We remark here that the plotted

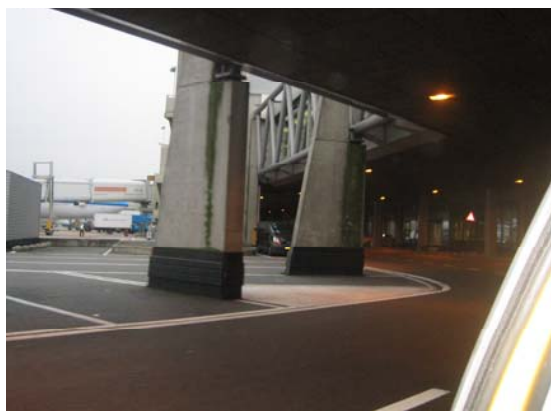
Fig. 11. Ring-road underpassing a pier at Schiphol Airport.

To check the large position errors around the D-pier, in Fig. 12 this area is zoomed in, and one may see that in this part the ring-road underpasses the terminal building and pier at frequent places (see also Fig. 11). As a consequence, multipath can be severe (at some places even no direct lines-of-sight may be received at all), and the resulting position gets biased. This bias can be up to 100 m, see Fig. 12.
