# DEEP LEARNING-BASED OBJECT DETECTION FOR EFFLORESCENCE RECOGNITION IN MASONRY

MASTER OF SCIENCE ARCHITECTURE, URBANISM AND BUILDING SCIENCES  
GRADUATION STUDIO BUILDING TECHNOLOGY

TITLE	<i>Exploring the potential of deep learning based image analysis for efflorescence recognition in masonry.</i>
DOCUMENT	MSc. Graduation Thesis
VERSION	1.0
STATUS	Final
DATE	October 21 <sup>st</sup> 2025
AUTEUR	V.C. (Valentijn) Cloo
STUDENT NR.	5436958
INSTITUTE	Delft University of Technology
DEGREE	Master of Science Architecture, Urbanism and Building Sciences
DEPARTMENT	Architectural Engineering + Technology
TRACK	Building Technology
ADRES	Julianalaan 134, 2628 BL Delft
1 <sup>st</sup> MENTOR	Dr. Barbara Lubelli
TITLE	Associate Professor
CHAIR	Heritage & Architecture
2 <sup>nd</sup> MENTOR	Dr. Azarakhsh Rafiee
TITLE	Assistant Professor
CHAIR	Geographic Information System Technology

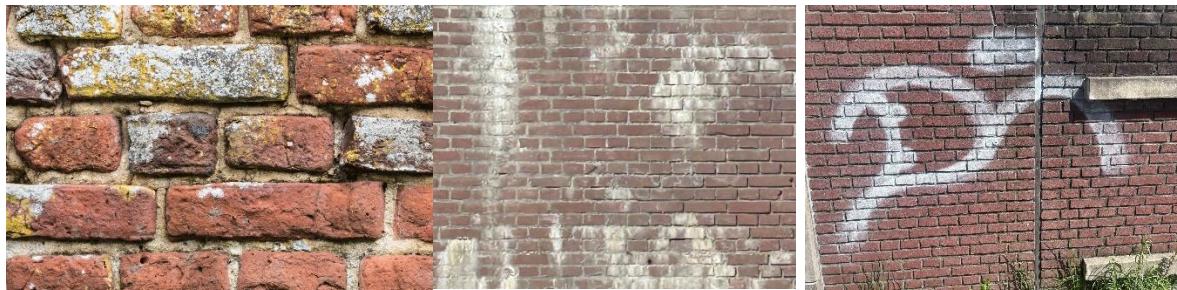
Figure 5 Examples of surface phenomena visually similar to efflorescence on Dutch masonry: (left) biological growth (lichens/mold) on a historic brick façade, (middle) encrustation deposits on a quay wall in Amsterdam, and (right) graffiti on a masonry wall in Delft

look-alike phenomena as seen in figure 5, are not damage mechanisms in the structural sense, but they increase the risk of misclassification during visual or image-based surveys.

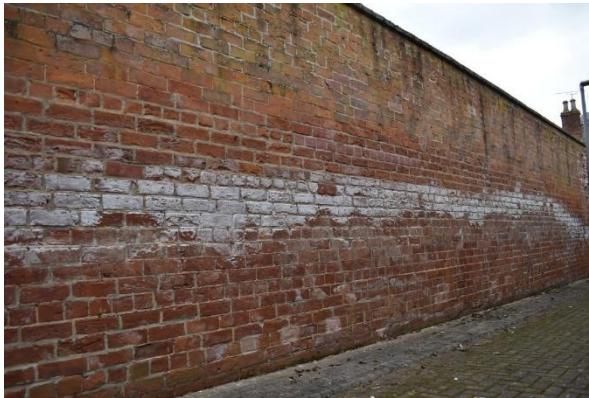
Figure 7 Rising damp schematic section of a masonry wall

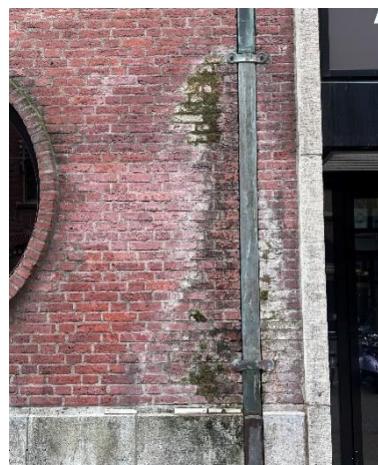
The efflorescence extends from the top of the pipe upwards, suggesting leakage from the drainage system. The contrast between the affected and unaffected brick areas emphasizes the localized nature of moisture-related damage.

Figure 10 Efflorescence and Biological Growth Near a Drainpipe on a Masonry Wall

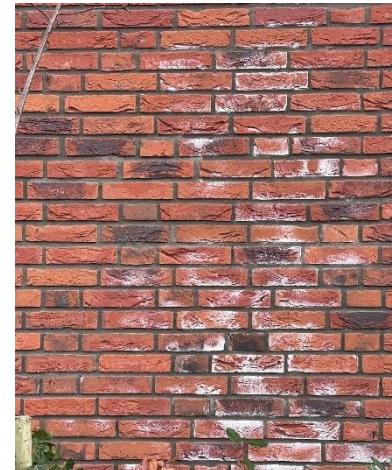
Figure 9 Early Onset of Efflorescence on a Newly Built Masonry Wall

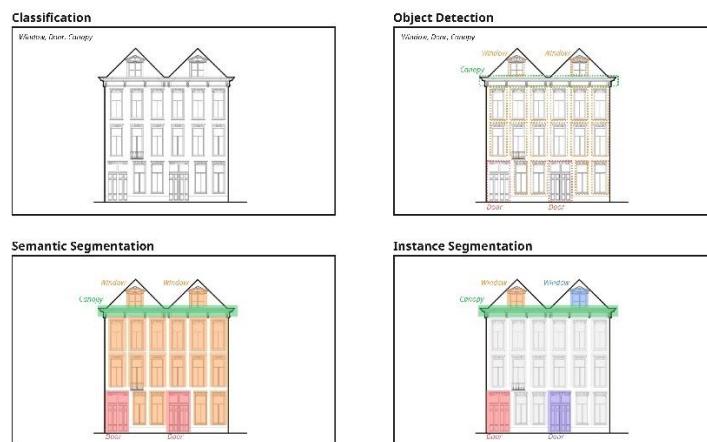
Figure 12 Illustration of the primary computer vision tasks: (a) image-level classification, (b) bounding-box object detection, (c) pixel-wise semantic segmentation, and (d) instance-level segmentation. Adapted and illustrated based on Liu et al. (2020).

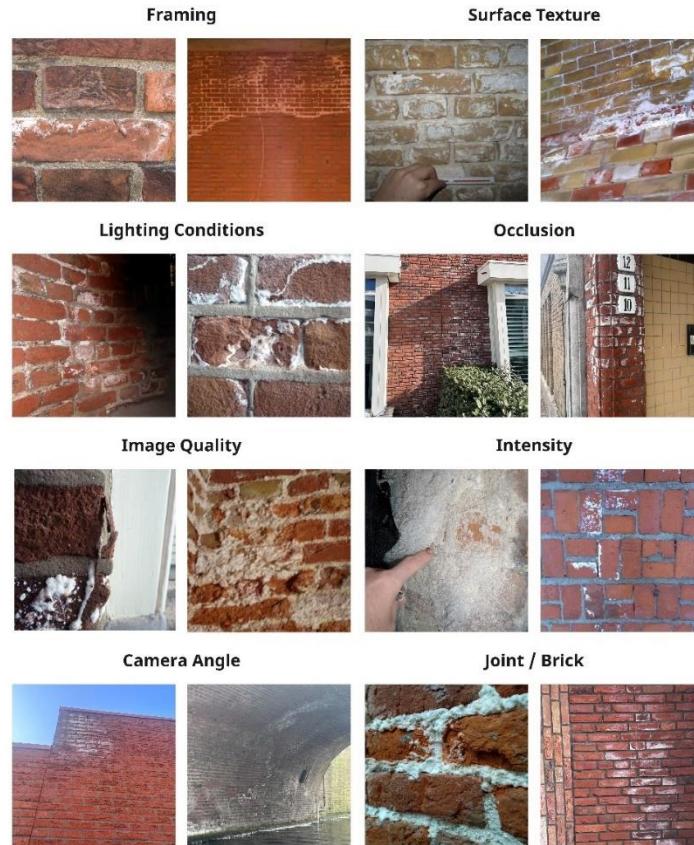
Figure 23 Visual examples of dataset diversity in efflorescence images. Variations in framing, surface texture, lighting, occlusion, image quality, intensity, camera angle, and efflorescence location

To enhance the robustness and generalizability of the model, the dataset incorporates a broad range of visual diversity. As shown in *Figure 21*, this includes differences in framing (close-ups versus façade-wide views), surface textures, lighting conditions (natural daylight, low-light environments),

and occlusion from surrounding elements such as vegetation or infrastructure. Additionally, the dataset varies in image quality—ranging from sharp, high-resolution captures to pixelated or motion-blurred images—along with efflorescence intensity, which spans from subtle staining to dense crusts as seen in figure 23. Perspective differences caused by camera angles and the decision to annotate efflorescence on joints or full bricks also contribute to learning complexity. Accounting for these factors is critical, as noted by Liu et al. (2020), who emphasized the role of intraclass variability and environmental conditions in object detection challenges.

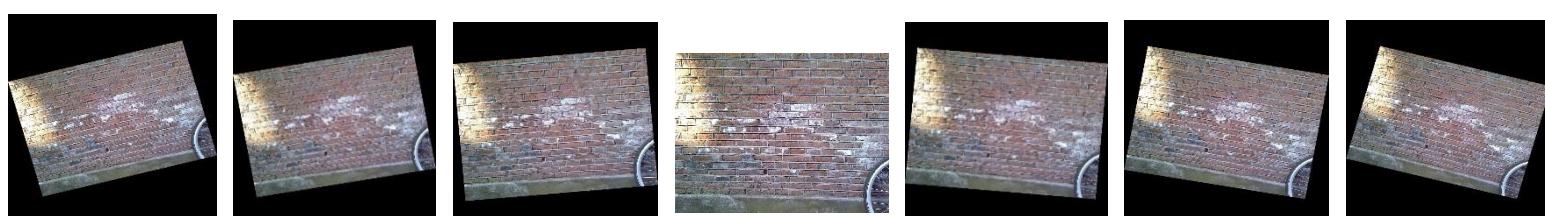
Figure 26 Camera Angle (Rotation). Left to right: images rotated in steps of 5°, 10°, and 15° relative to the original orientation.

Rotational transformations were used to simulate changes in camera angle. Each image was rotated around its center at 5°, 10° and 15° (both clockwise and counterclockwise), resulting in 8 rotated variants per image as shown in figure 26.

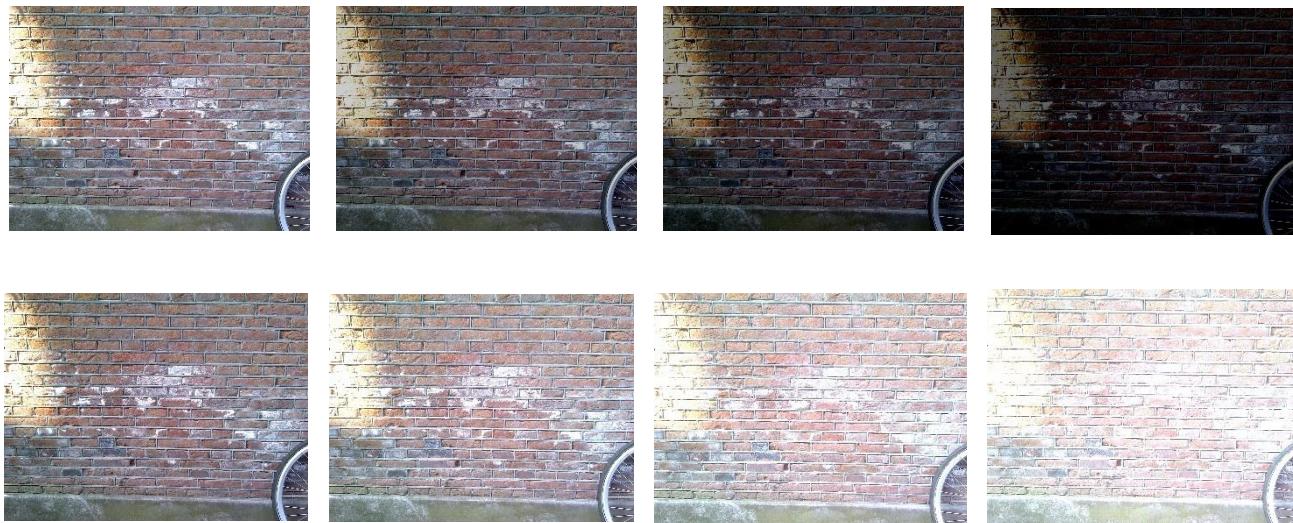
Figure 29 Lighting / Exposure. Left to right: brightness and contrast adjusted in steps of  $\pm 10\%$ ,  $\pm 20\%$ , and  $\pm 30\%$ .

Photometric distortion was applied through controlled contrast and brightness shifts as shown in figure 29. Brightness was adjusted in steps of  $\pm 10\%$ ,  $\pm 20\%$ , and  $\pm 30\%$ , and contrast in  $\pm 10\%$ ,  $\pm 20\%$  and  $\pm 30\%$ , resulting in 7 lighting variants per image. These changes reflect typical environmental variability (e.g., overcast vs. direct sun).

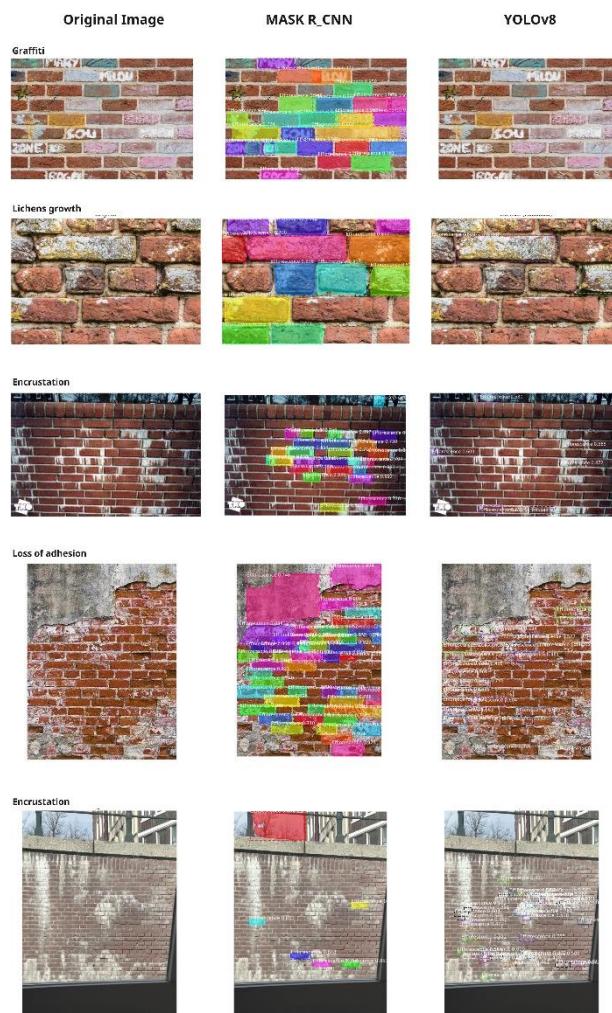
Figure 36 Comparison of detection results of non-efflorescence damages.

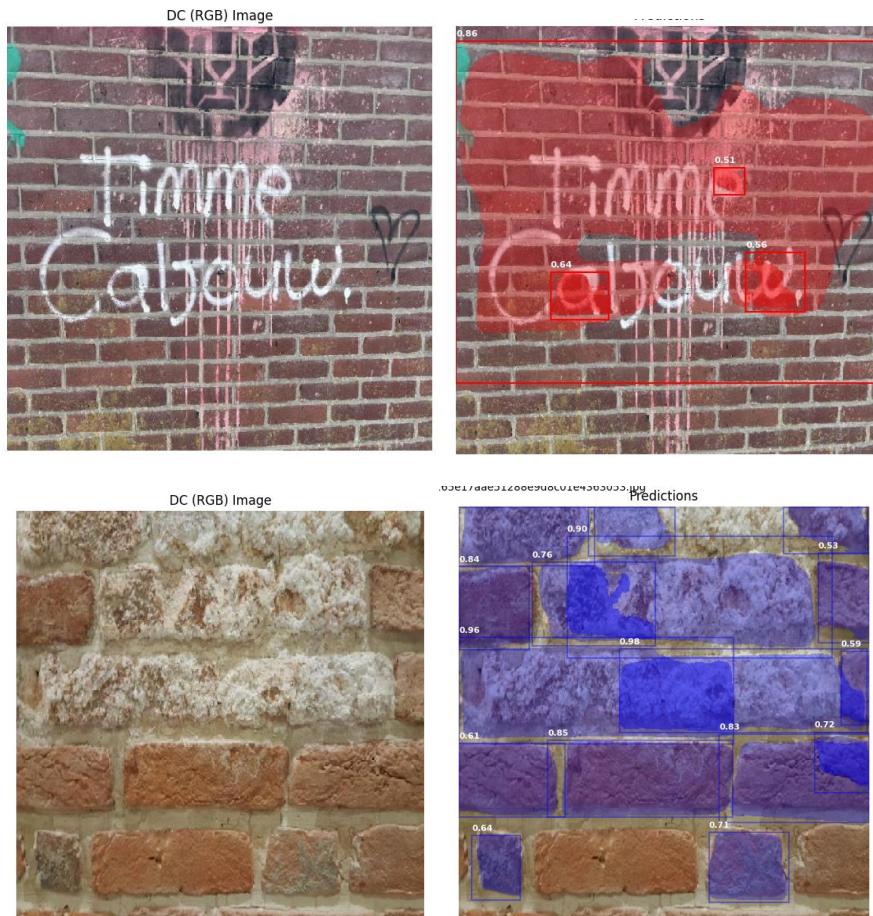
Figure 44 Efflorescence and Graffiti predictions results with confidence scores (Epoch 60) (1) Original graffiti image. (2) Graffiti prediction. (3) Original Image: (4) Efflorescence prediction.

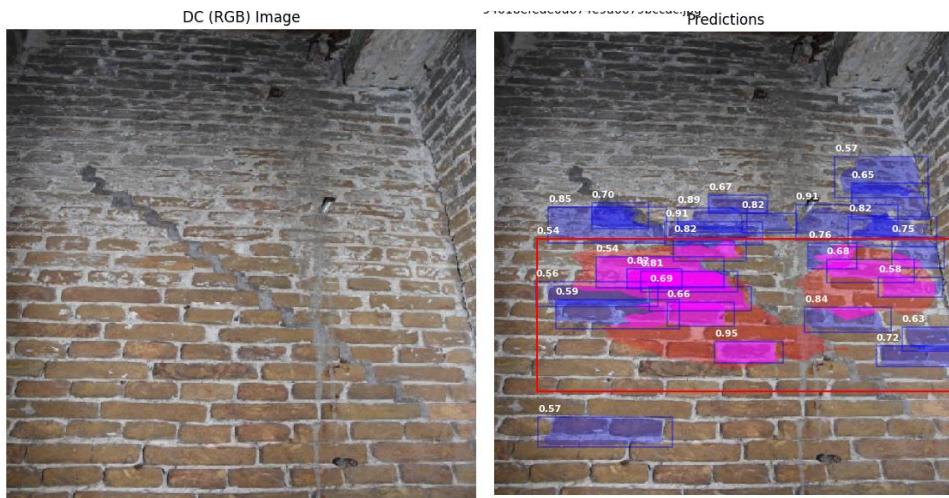
Figure 46 Efflorescence and encrustation predictions results with confidence scores (Epoch 60) (1) Original efflorescence image. (2) Efflorescence and (falsely) Encrustation prediction.

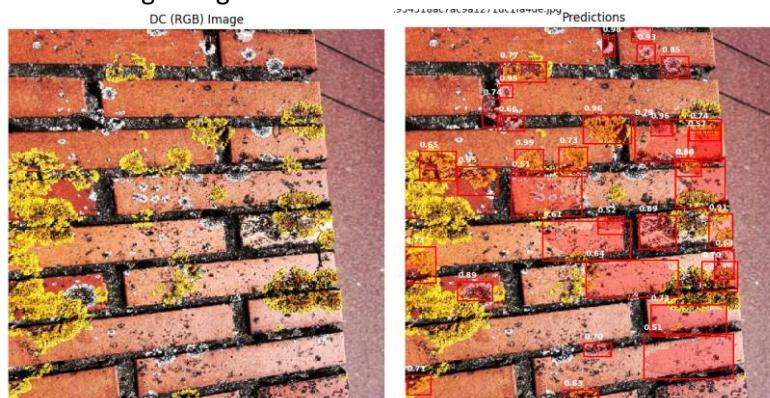
Figure 47 Efflorescence and Lichens predictions results with confidence scores (Epoch 60) (1) Original Lichens image. (2) Lichens prediction

When linking this outcome to loss functions, the results imply that both classification and bounding box regression losses were successfully minimized for the lichen class. This is supported by the dense and accurate bounding box predictions in the image of figure 47, each with high confidence scores and precise alignment with visible lichen patches. Moreover, the absence of false positives indicates that the model has learned good class separation in feature space, which reflects a well-optimized classification loss.

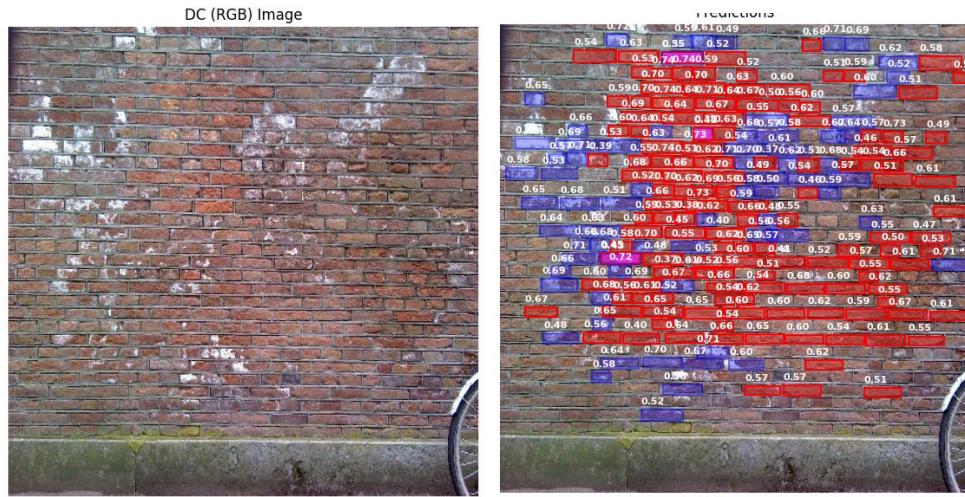
Figure 53 Efflorescence and damage predictions results with confidence scores (Epoch 60) (1) Origina image. (2) Efflorescence and damage prediction.

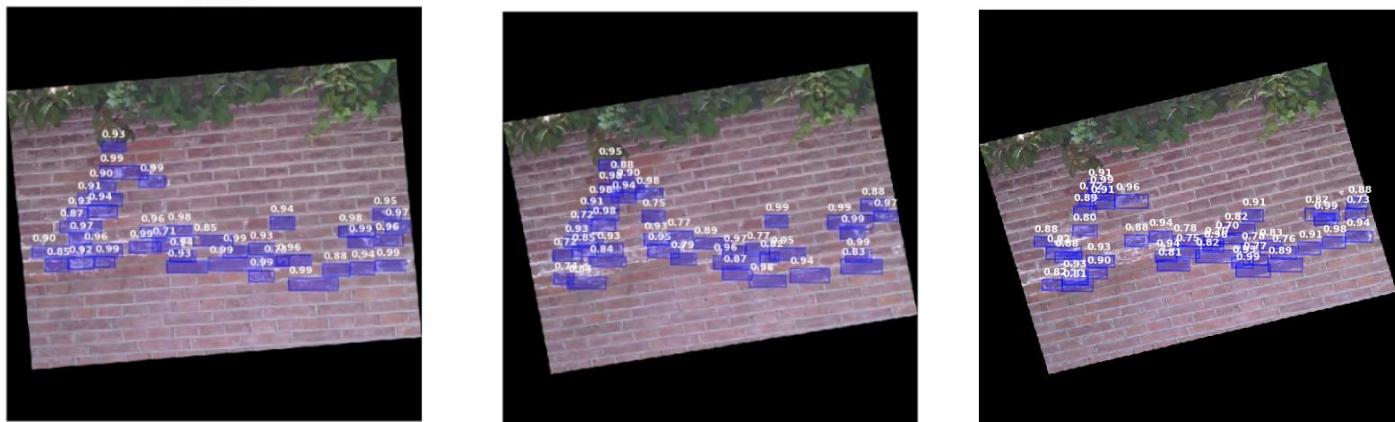
Figure 60 Predicted masks under input rotation ( $5^\circ$ ,  $10^\circ$ ,  $15^\circ$ ) compared to the baseline.

As shown in Figure 60, the model demonstrates moderate robustness to changes in camera tilt. In the  $\pm 5^\circ$  and  $\pm 10^\circ$  rotation cases, most efflorescence bricks are still detected, and mask coverage remains consistent, although confidence scores start to drop slightly. However, at  $\pm 15^\circ$ , several key issues emerge:

- Some detections shift slightly from their correct positions, especially near the image edges.
- A few smaller bricks are missed altogether.
- Confidence values drop below 0.80 in multiple areas, signaling increased uncertainty.

Despite these issues, the model does not show major asymmetry between counterclockwise tilts rotational direction seems to have negligible effect, which aligns with the symmetrical performance trends seen in the mAP curves. This suggests that moderate angular shifts are tolerable, but stronger tilt begins to interfere with spatial consistency and mask placement.

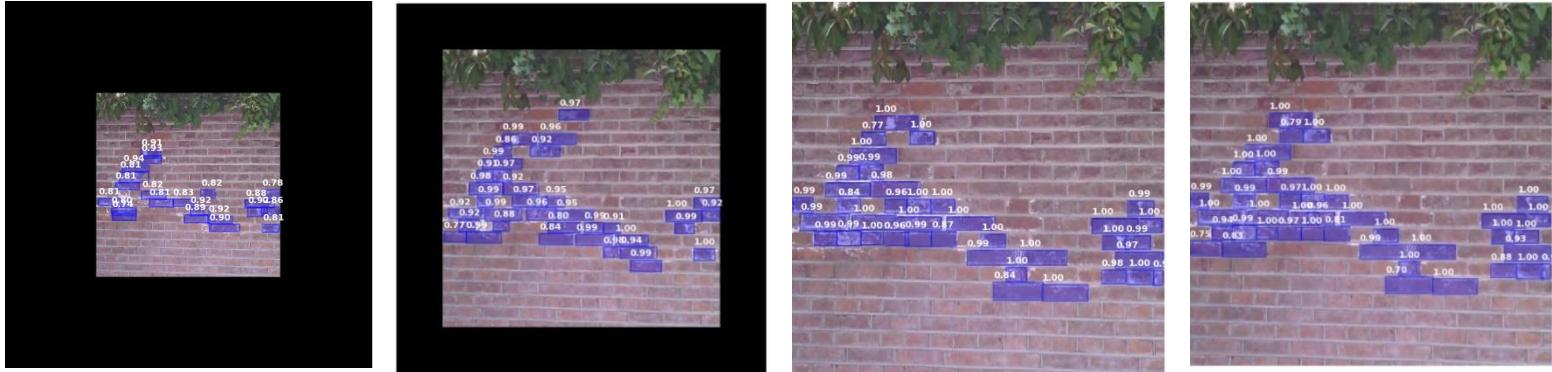
Figure 61 Predicted masks under input scaling ( $0.5\times$ ,  $0.75\times$ ,  $1.25\times$ ,  $1.5\times$ ) compared to the baseline.

Downscaling the input ( $0.75\times$ ,  $0.5\times$ ) leads to clear losses in mask resolution. Efflorescence is under-segmented, and minor patches disappear entirely. Upscaling ( $1.25\times$ ,  $1.5\times$ ) slightly enhances boundary detail but also introduces noise around edges, particularly at  $1.25\times$ . The base image  $1.5\times$  variant yield the most visually coherent results, highlighting a trade-off between scale enlargement and noise amplification.

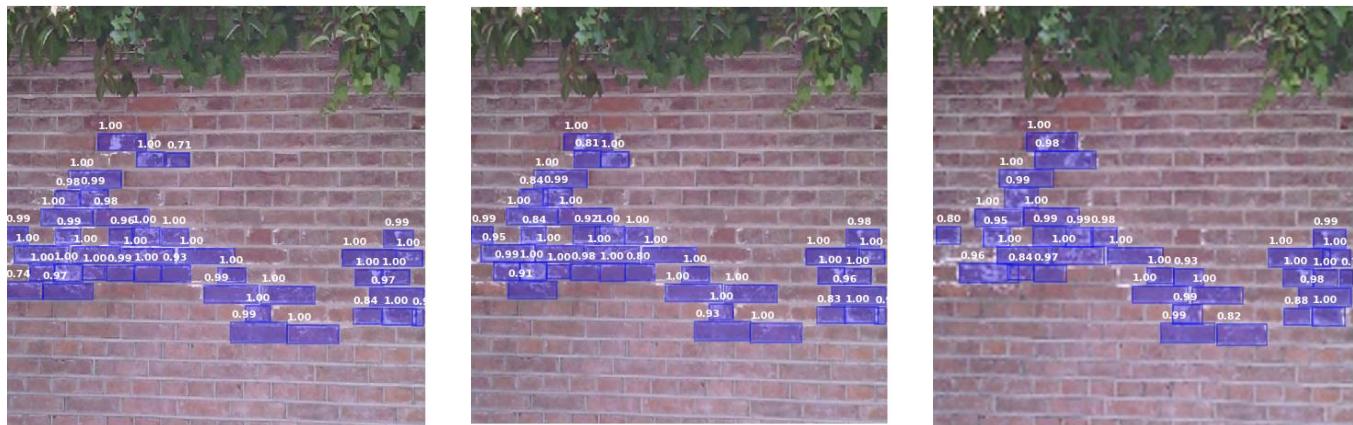
Figure 62 prediction masks at different input resolutions (480px, 320px, 160px) alongside the baseline.

Reducing image resolution to 320 and 160 pixels substantially degrades visual performance. At 160px, predictions are patchy, misaligned, or completely missing, with efflorescence often undetected. The 480px variant performs comparably to the original high-resolution image, producing reasonably clean contours. This confirms that fine-grained detail is critical for accurate mask generation, especially for subtle or edge-bound efflorescence patterns

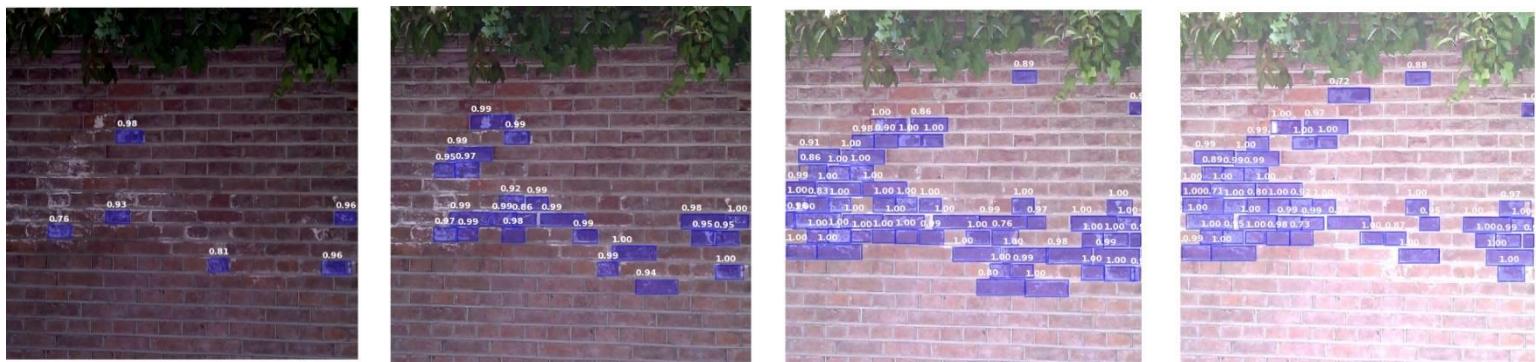
Figure 63 Prediction comparisons for brightness/contrast augmentation ( $\pm 10\%$ ,  $\pm 20\%$ ) versus the baseline

Predictions on images with moderate brightness increases (+10%) show noticeably improved mask confidence and completeness, with efflorescence outlines clearly defined. In contrast, darker variants (-10%, -20%) suppress mask visibility and produce fragmented or overly conservative detections. The

+20% variant exaggerates boundaries slightly but retains coherent coverage, suggesting the model is more robust to overexposure than underexposure.

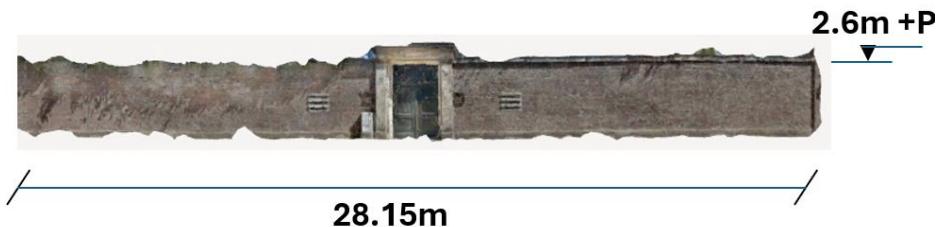
Figure 66 Orthographic elevation of the selected façade section (penant) along the Eerste Weteringdwarsstraat.
